MAHAFFEY ASSOCIATES PTY LTD (ABN 90 001 629 036)
Incorporating BEMAC Laboratories
Unit 9/108-110 Percival Rd (PO Box 2162) Smithfield NSW 2164
Ph (02) 9756 4003 Fax (02) 9757 4228 Email mahaffey@mahaffey.com.au

PROJECT: 39 Herbert Street Artarmon

SUBJECT: Water Penetration Testing of Cracks Treated with Radcon

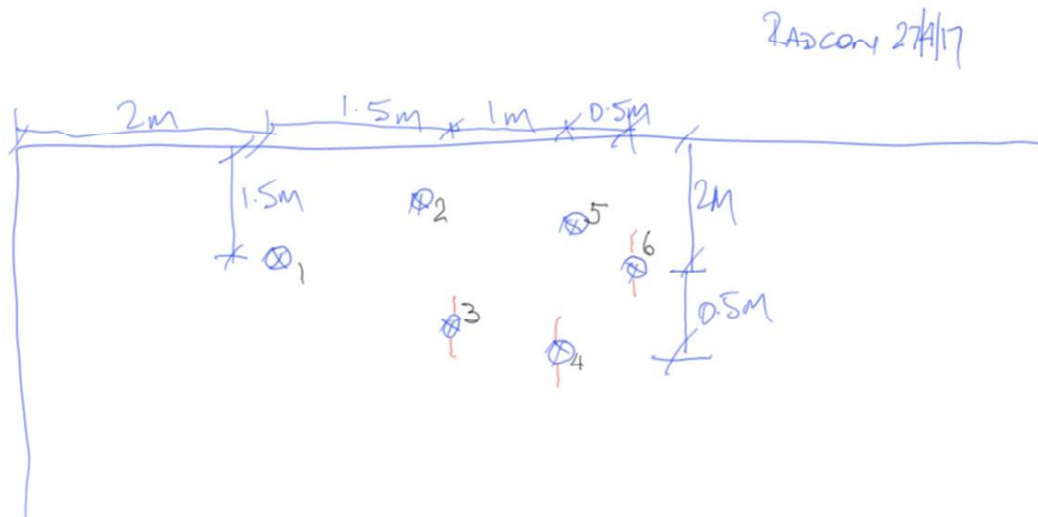
FIGURE 1 – Test Locations

An area was selected for testing and a series of reservoirs were set up on the top floor carpark slab. 6 reservoirs were set up in total, three over un-cracked concrete and three directly over cracks (see Photograph A1 in Appendix A). The locations of the reservoirs are shown in Figure 1.

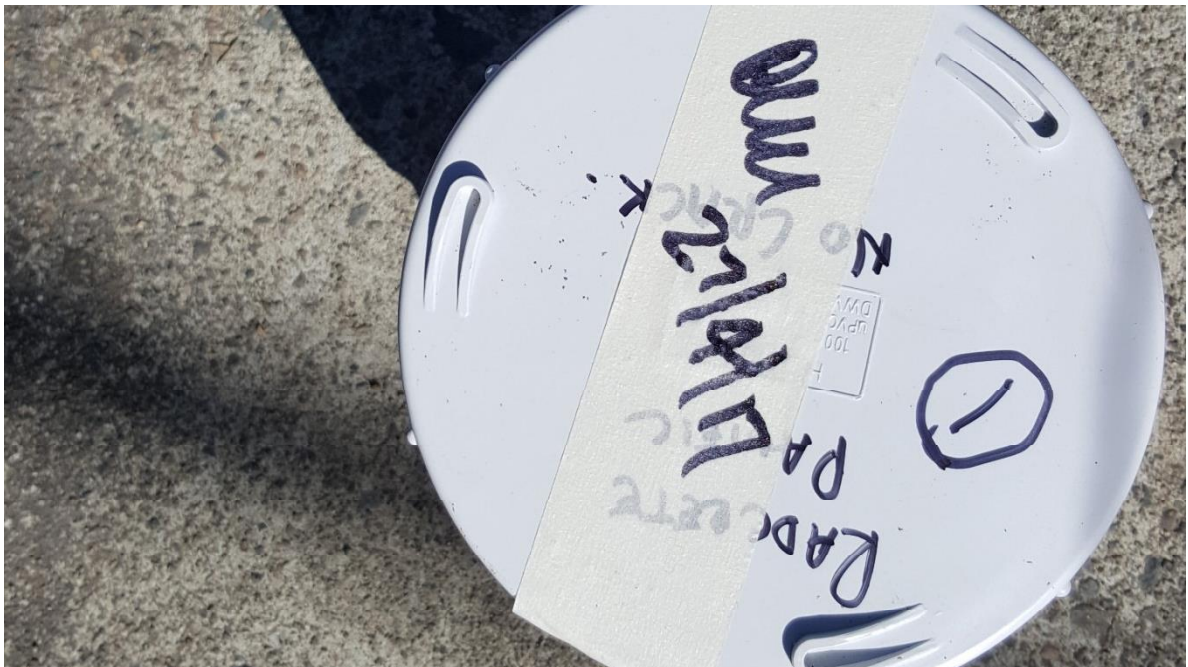
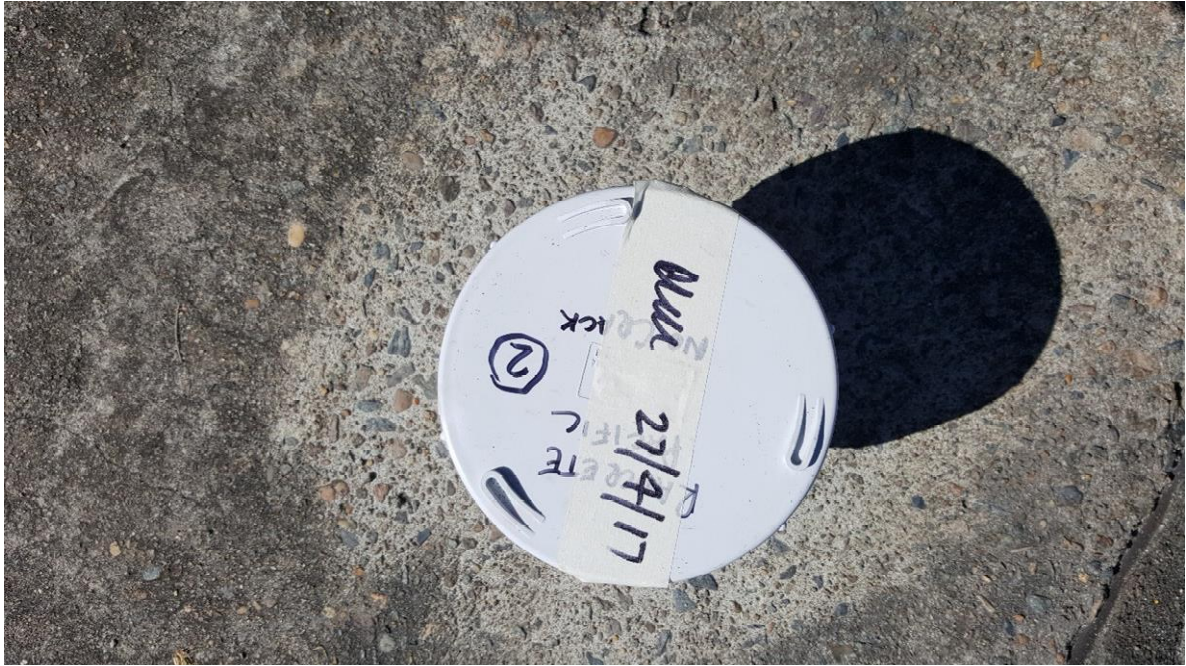
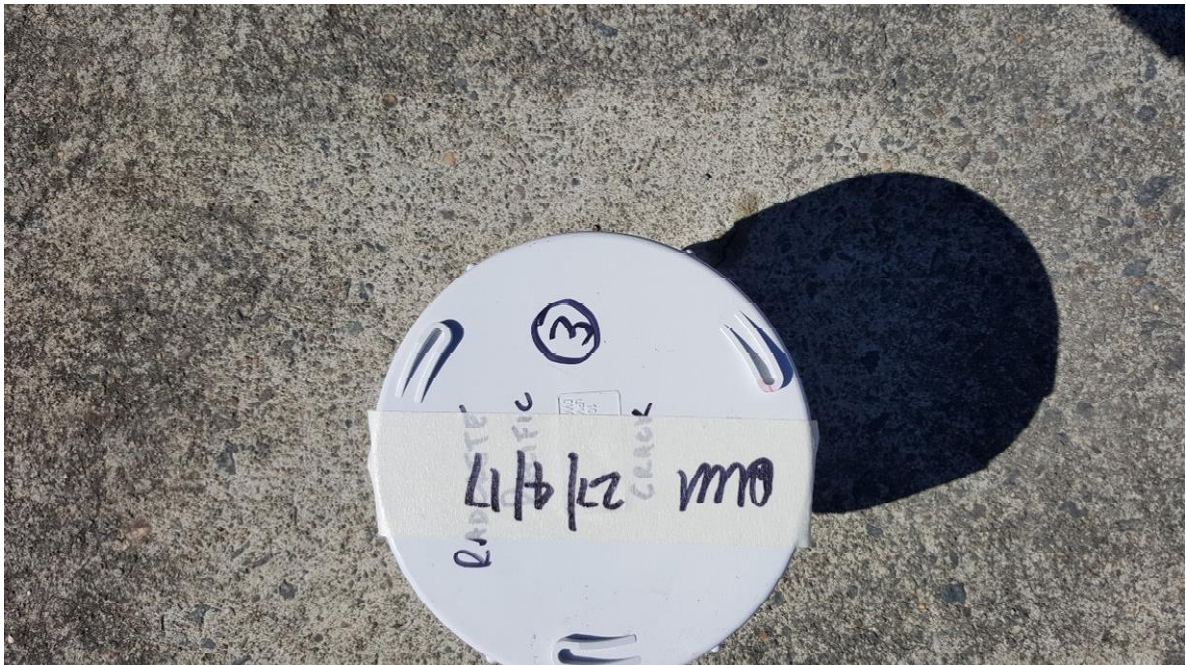
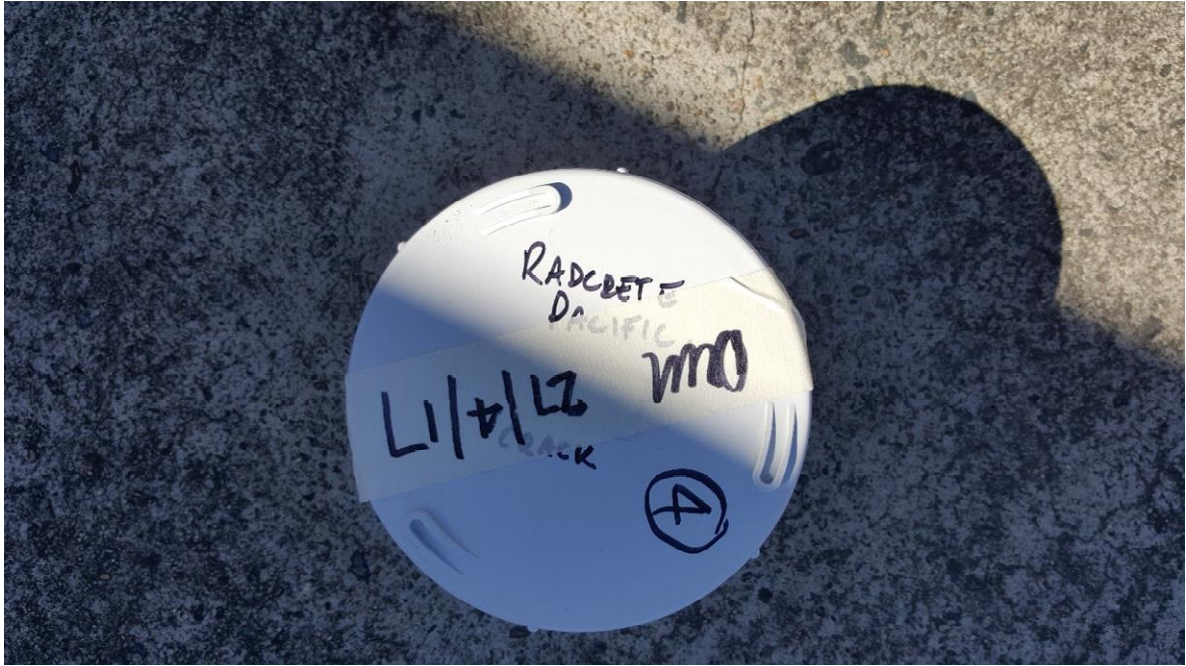
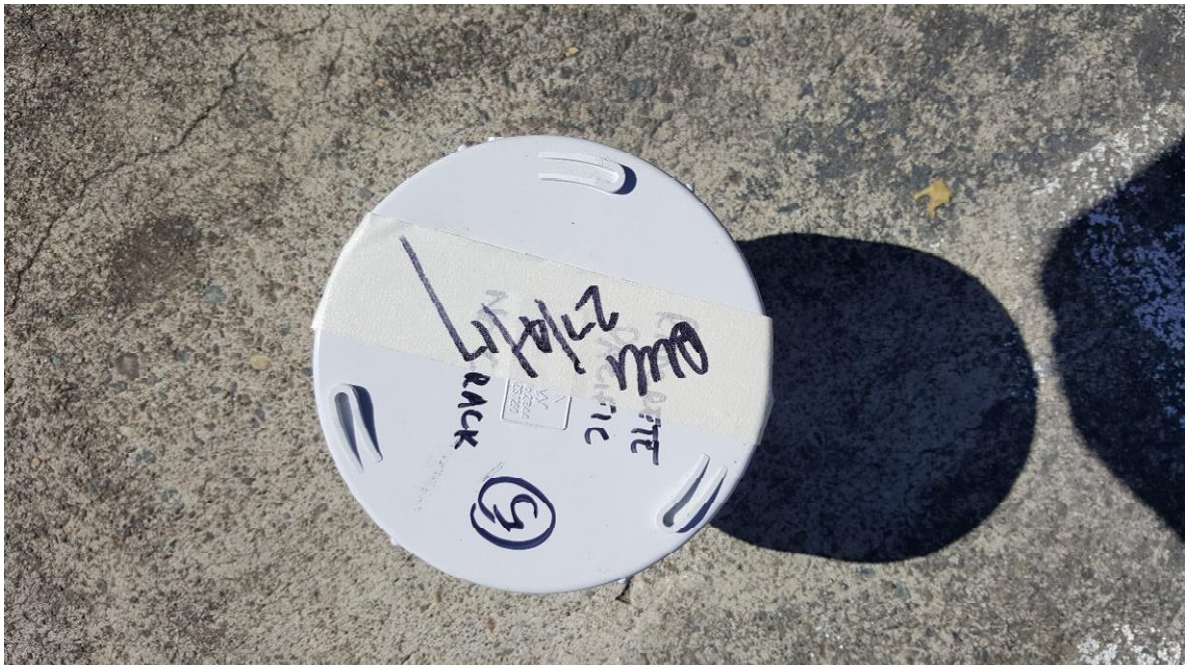
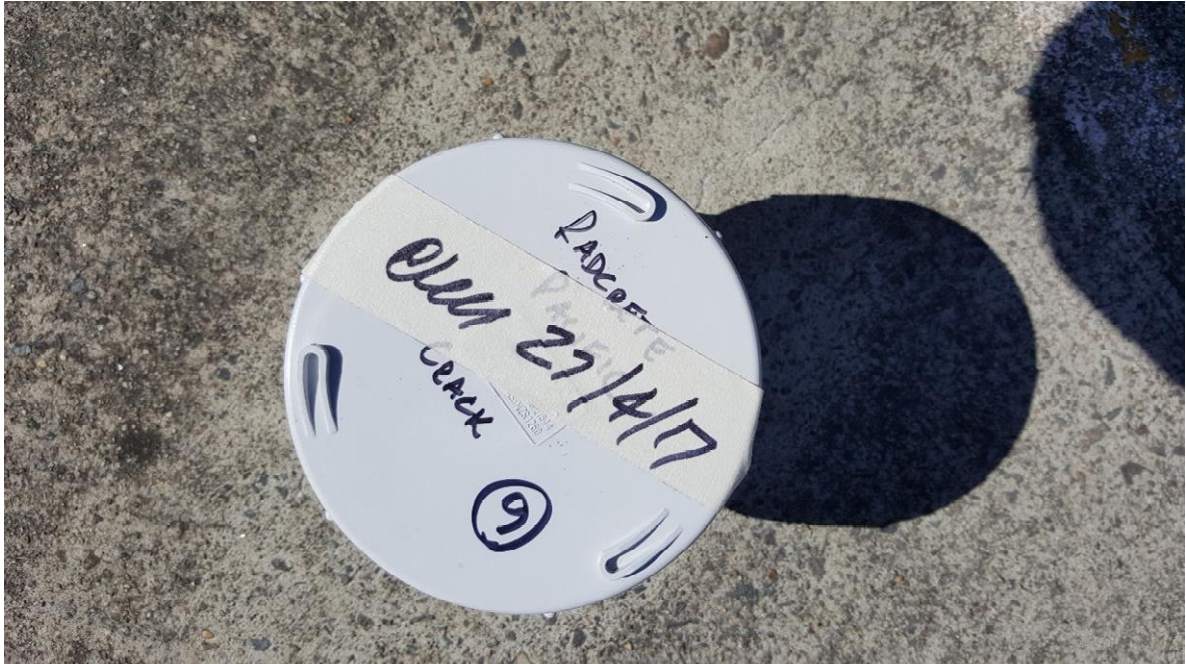
David Mahaffey (DM) attended site and filled the reservoirs with water. The reservoirs were filled to the top, so that any loss of water would be apparent. The depth of the reservoirs was 100-110mm. A screw-on cap was then placed onto each of the reservoirs and this was secured with tape. The tape was signed by DM so that there could be no question of tampering between visits. The caps were also used to prevent evaporation of water or to prevent filling with rain during the test period. The taped reservoirs can be seen in Photographs A2 to A7.

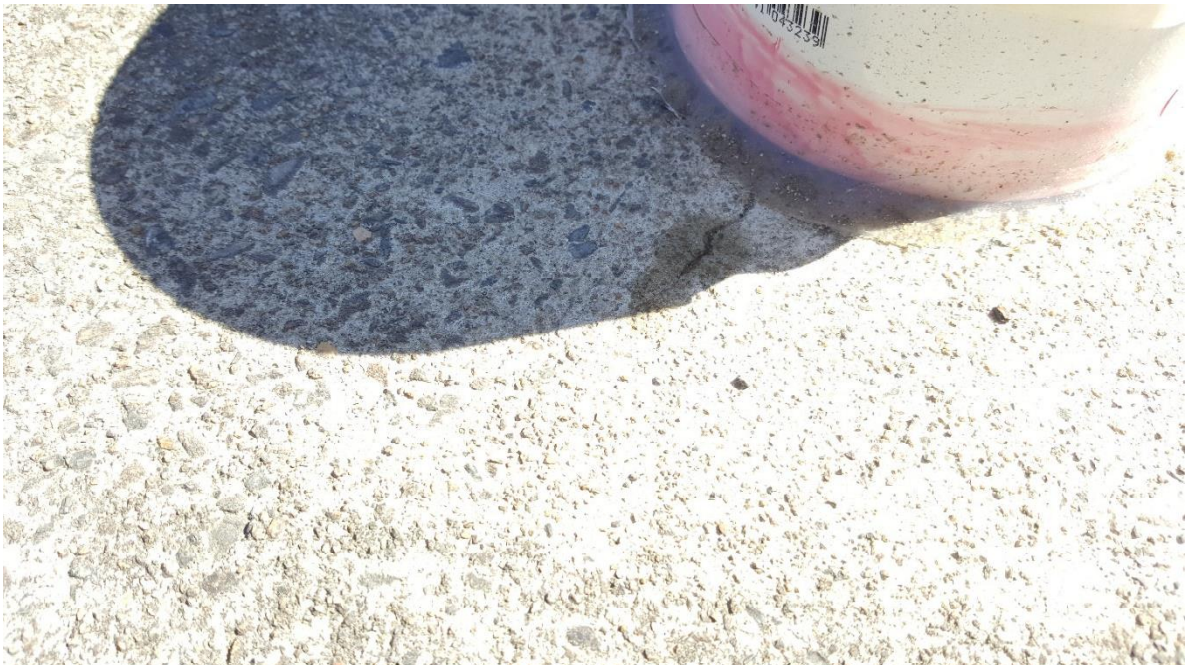
A8

Some initial movement of water into the crack could be seen at location 3 (see Photograph A8).

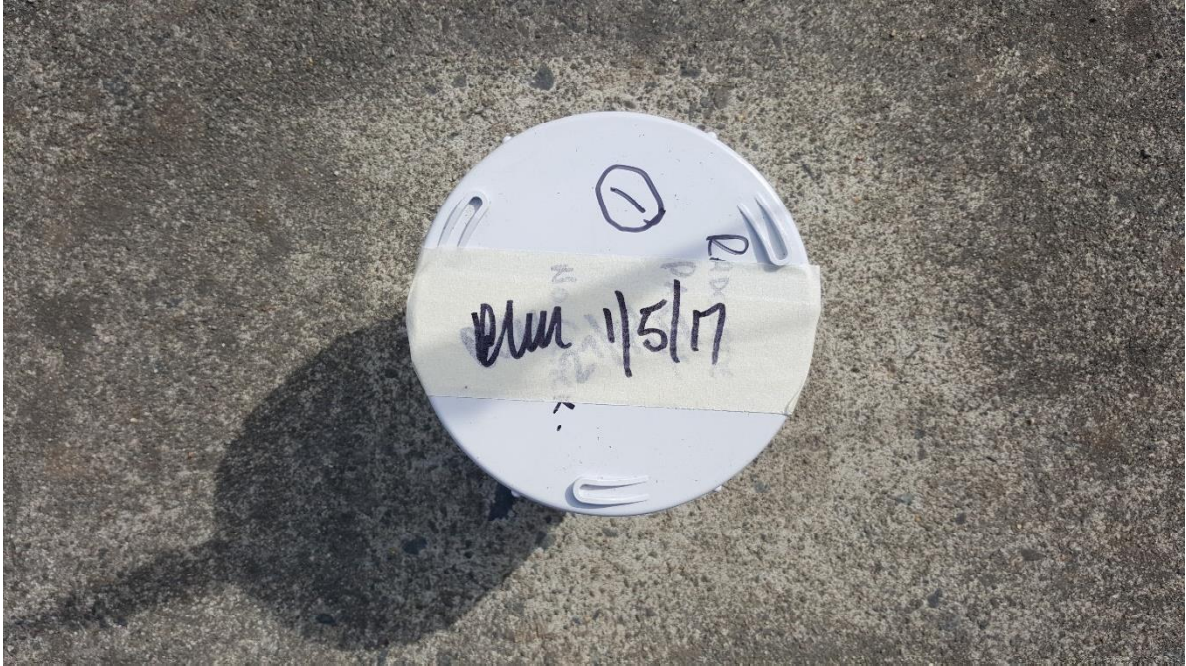
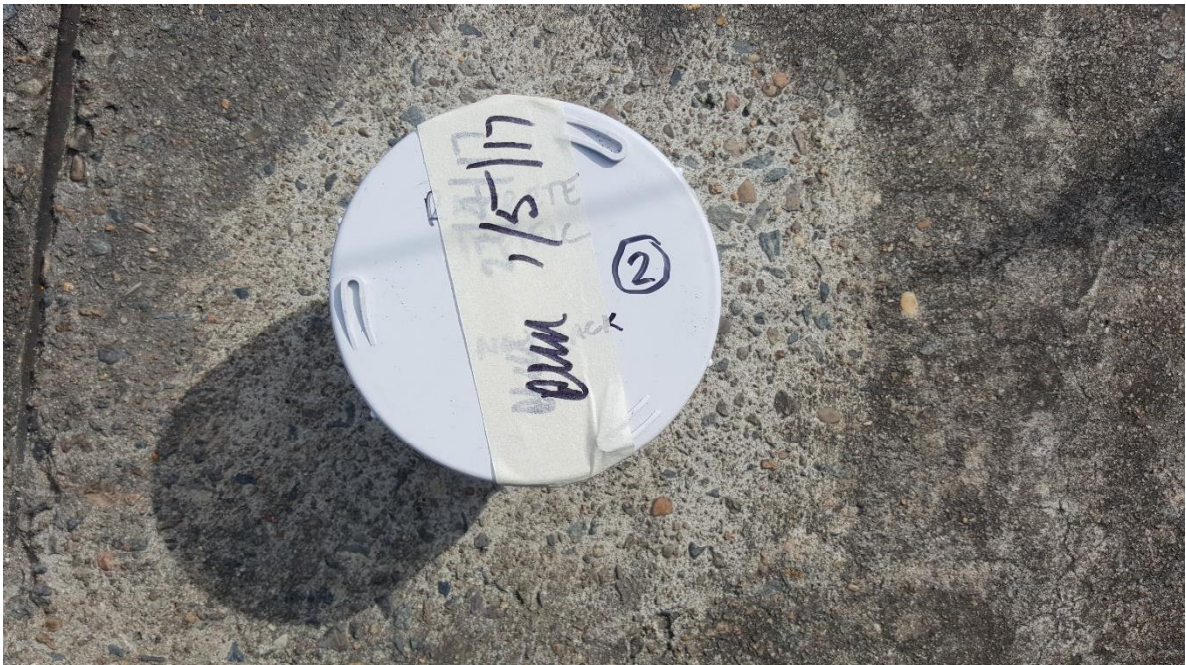
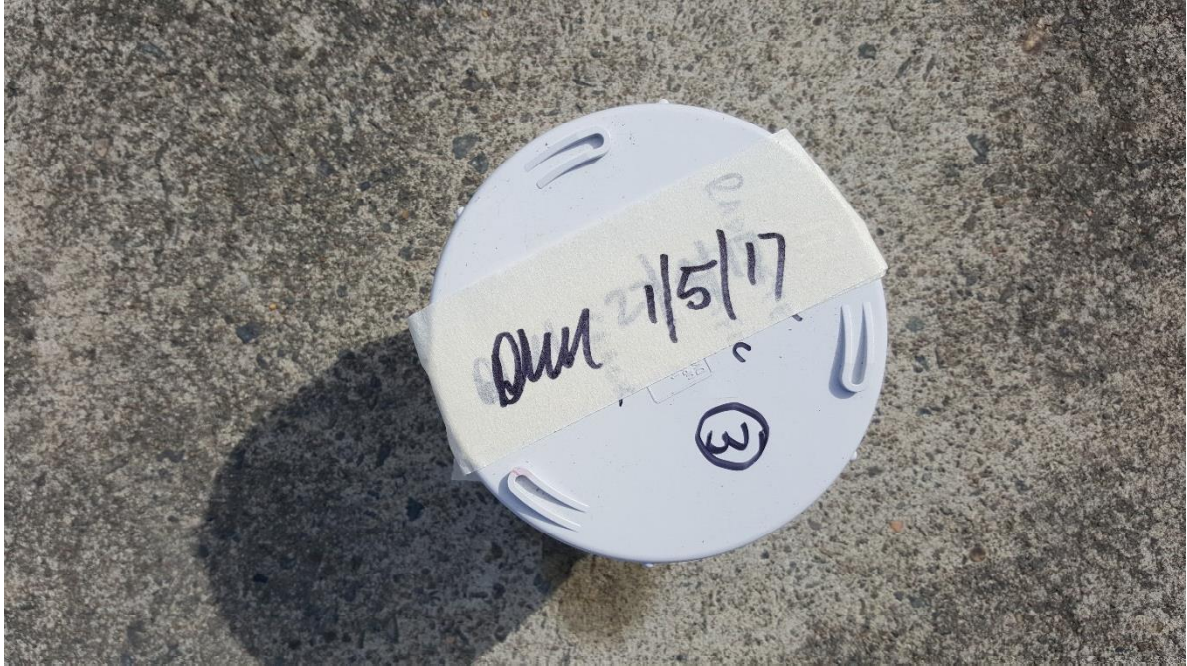
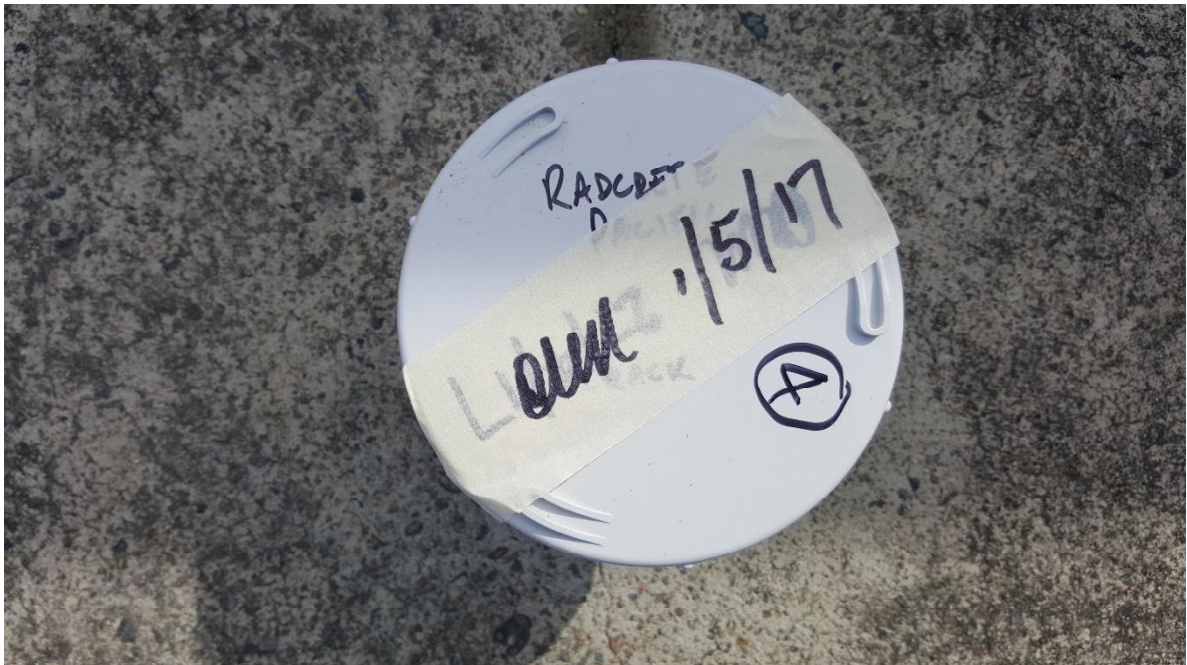
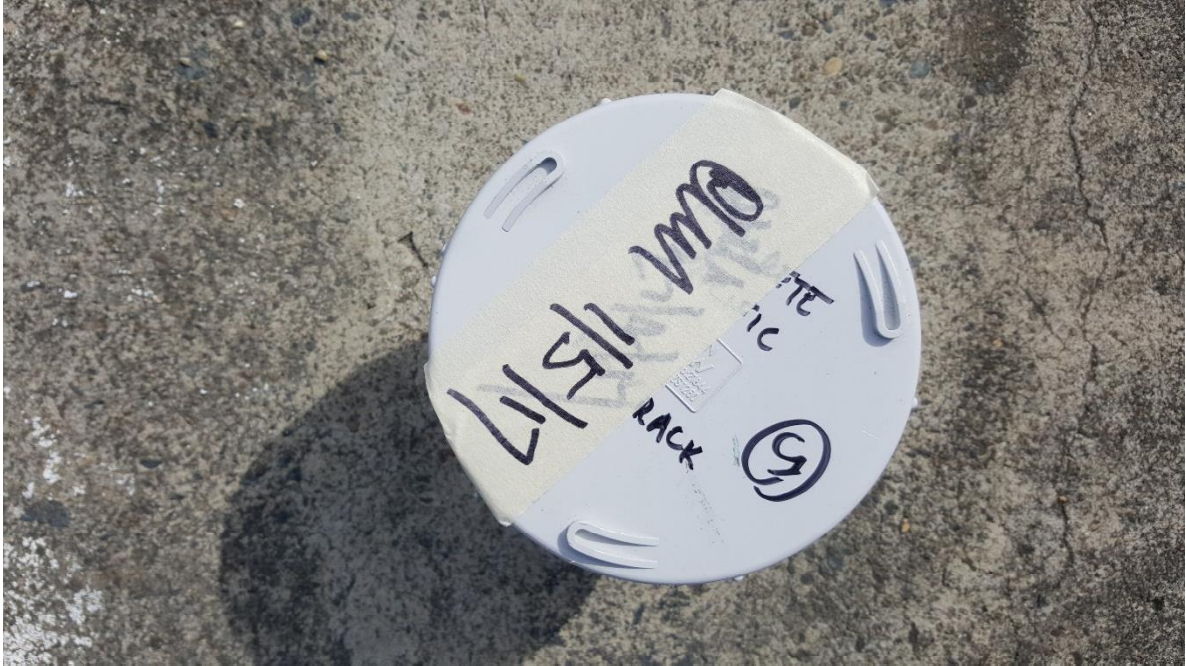
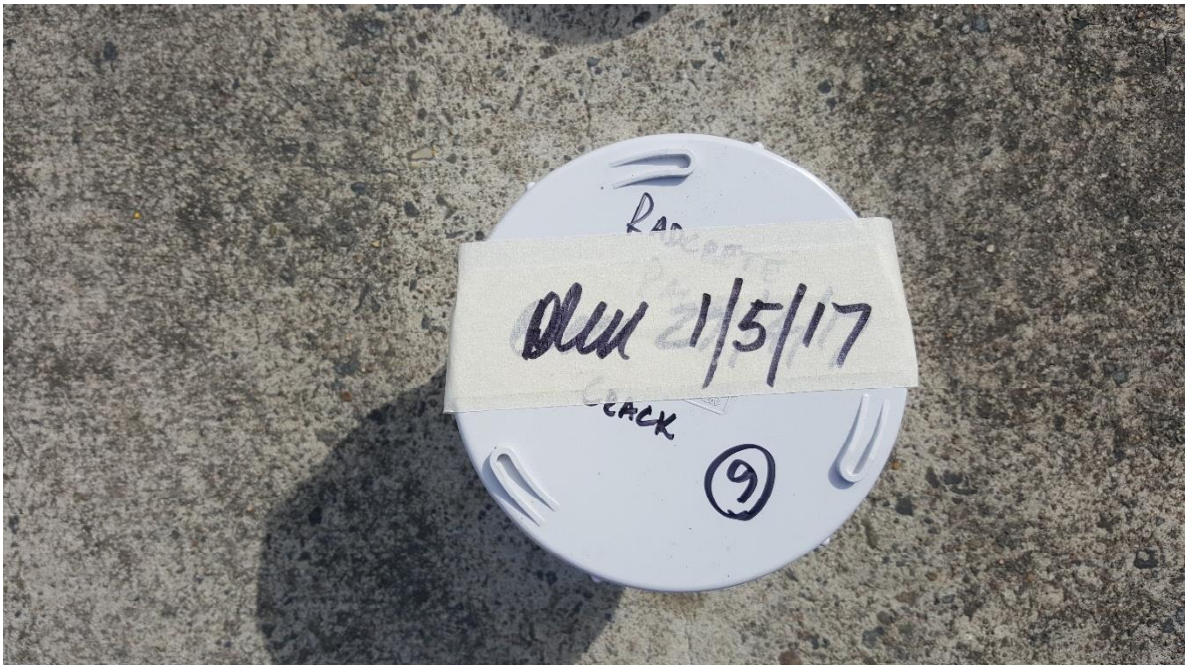
DM attended site, removed the caps from each of the reservoirs and topped up the water. Some very minor water loss had occurred in this initial period. This was not measured, as some initial absorption of water into the concrete surface was expected.

The caps were then placed back onto the reservoirs and re-taped (see Photographs B1 to B6 in Appendix B).

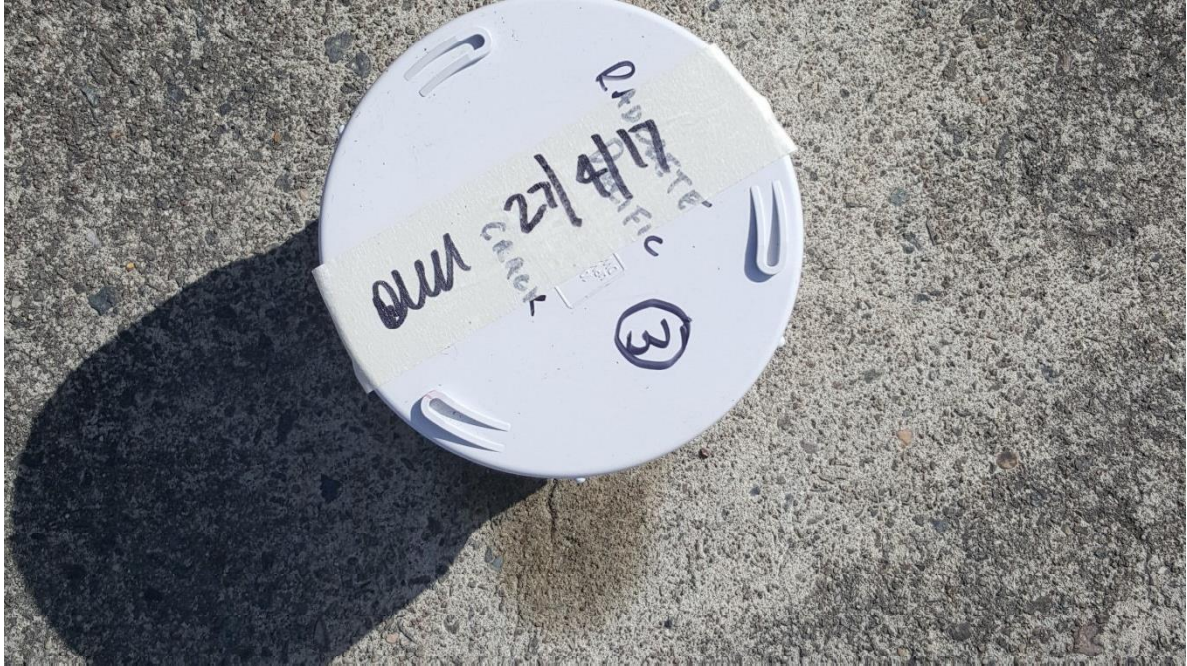
B7

The damp patch around the crack at location 3 was slightly larger than when the reservoirs were first filled (Photograph B7). Some initial movement of water into the crack could be

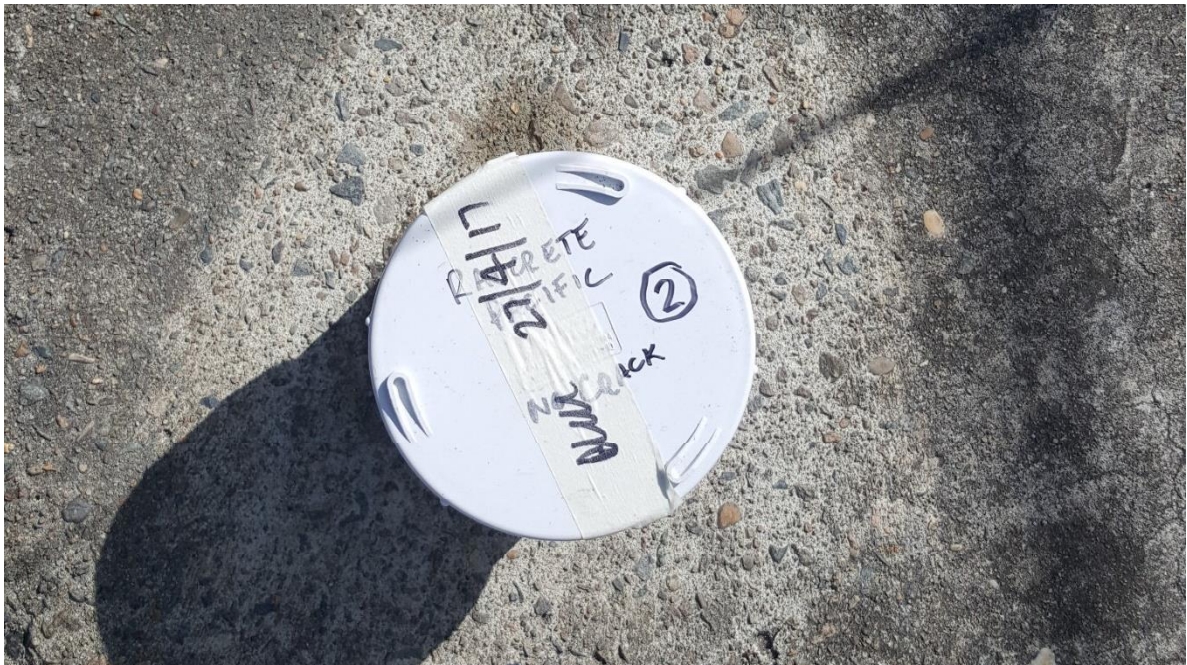
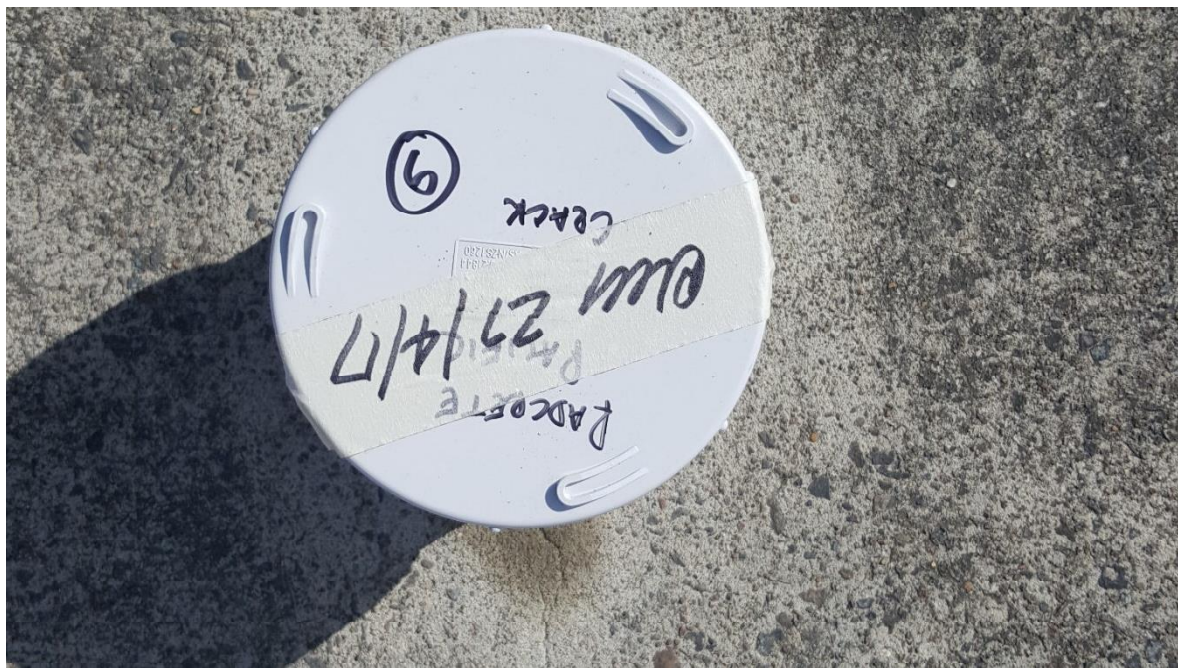
seen at locations 2 and 6 (Photographs B8 and B9).

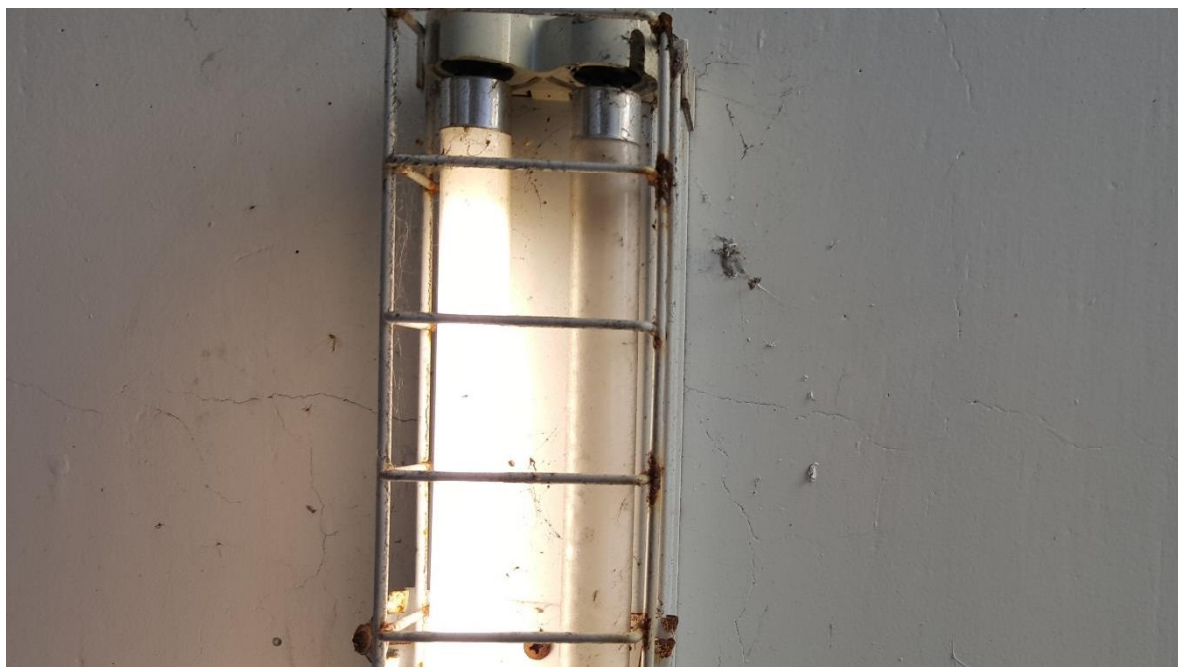
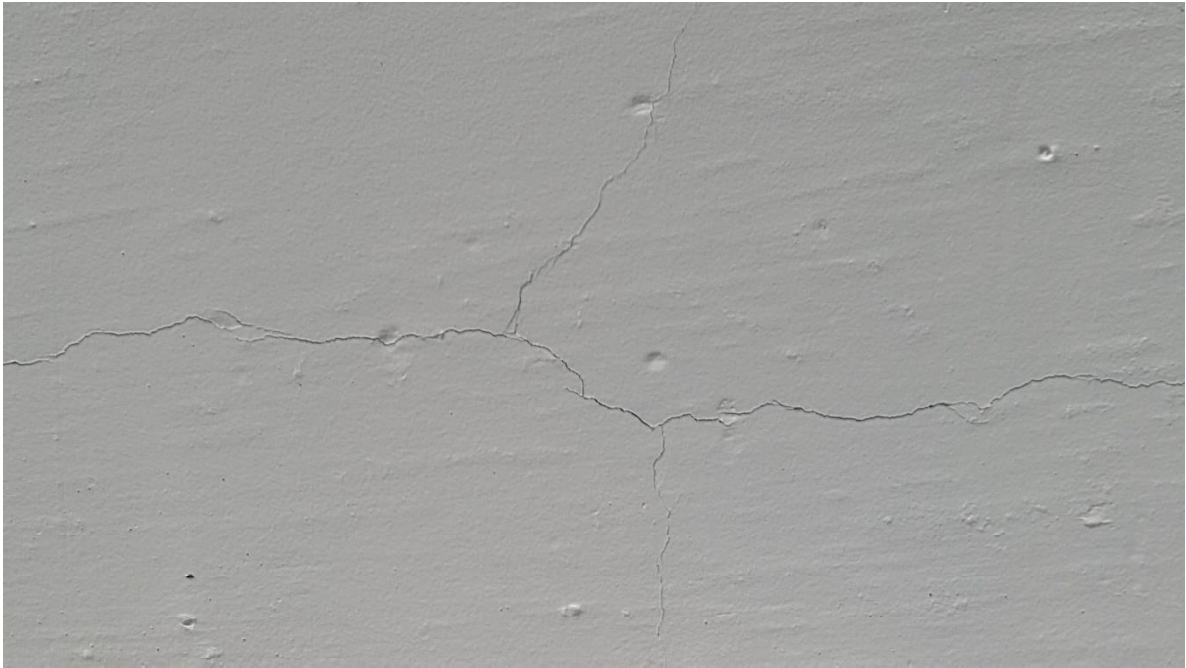
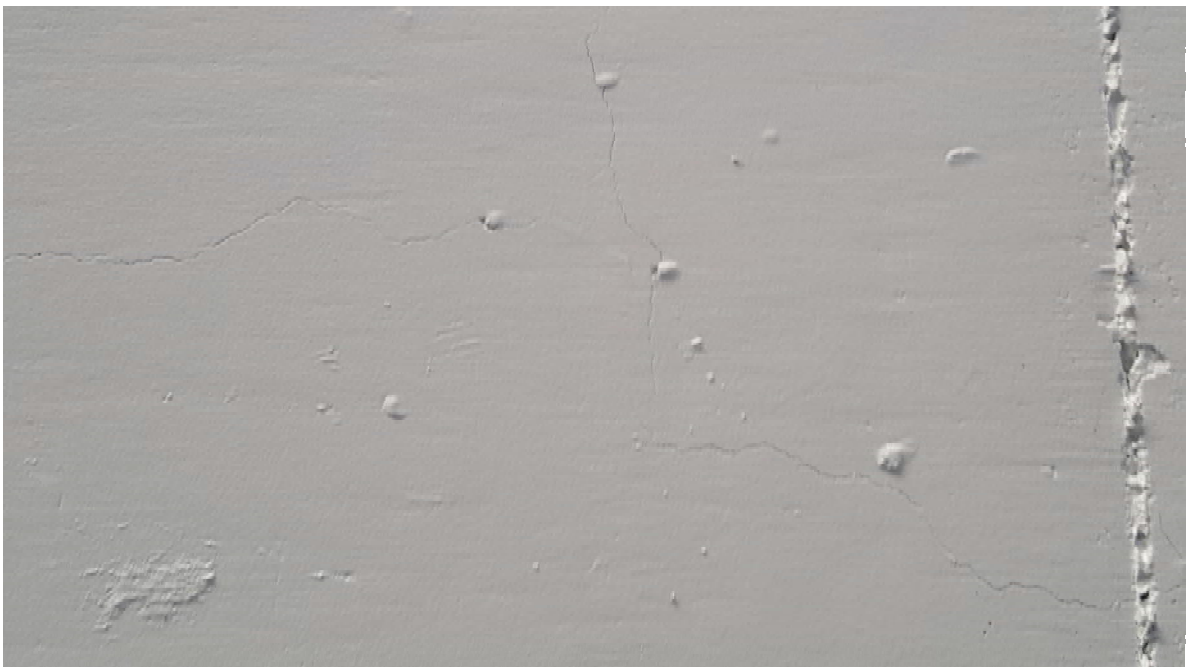
The slab soffit was inspected during this visit and the cracks below locations 2, 3 and 6 identified. No water penetration was observed at any of the cracks. These cracks can be seen in Photographs B10-12.

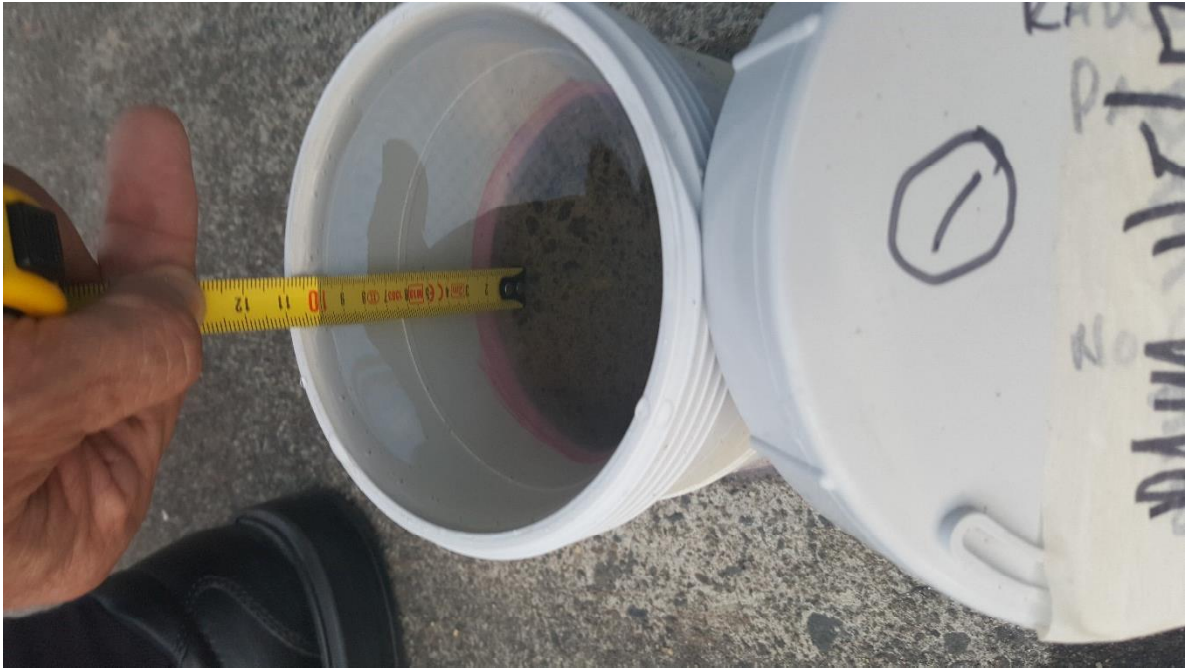
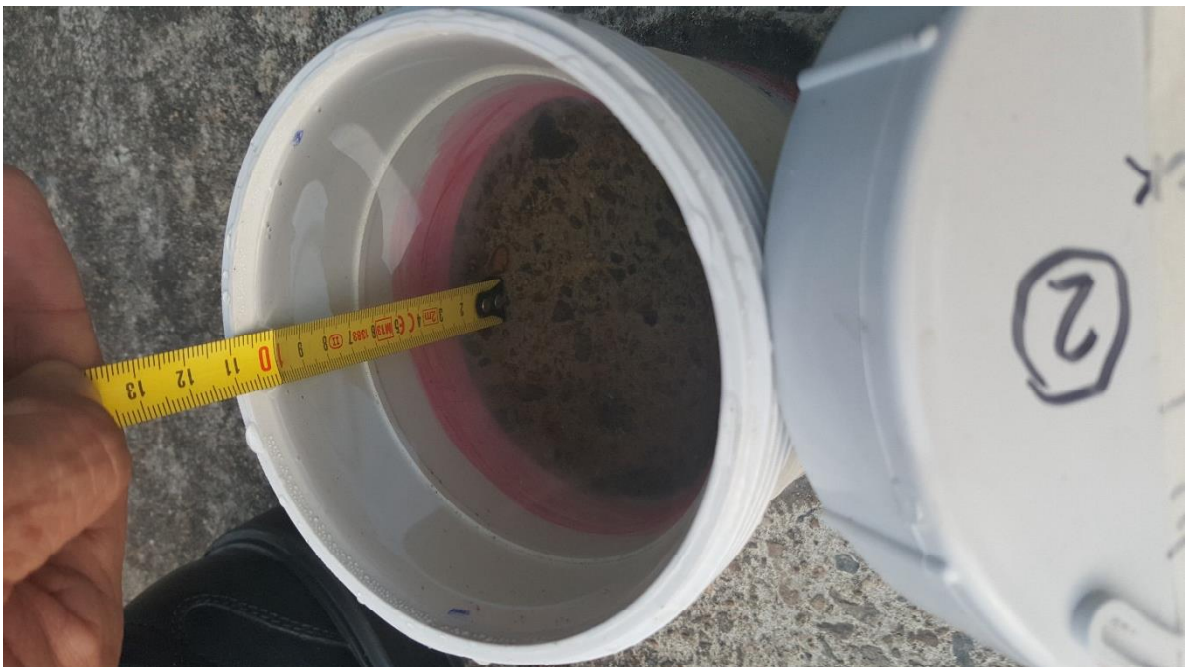
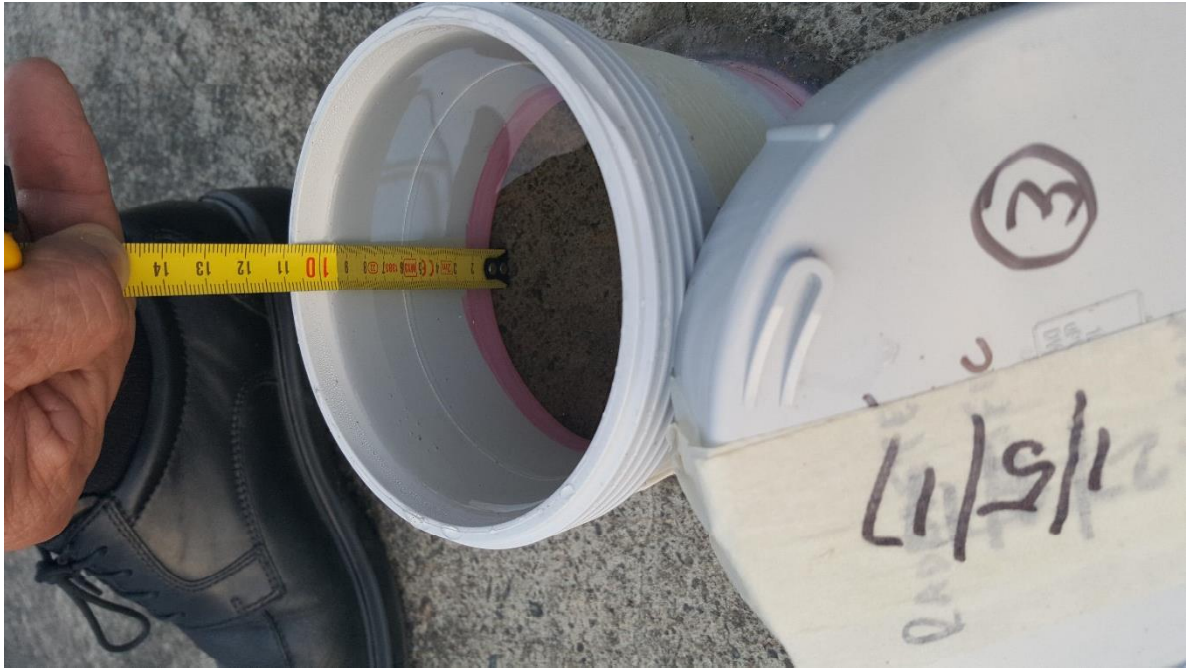
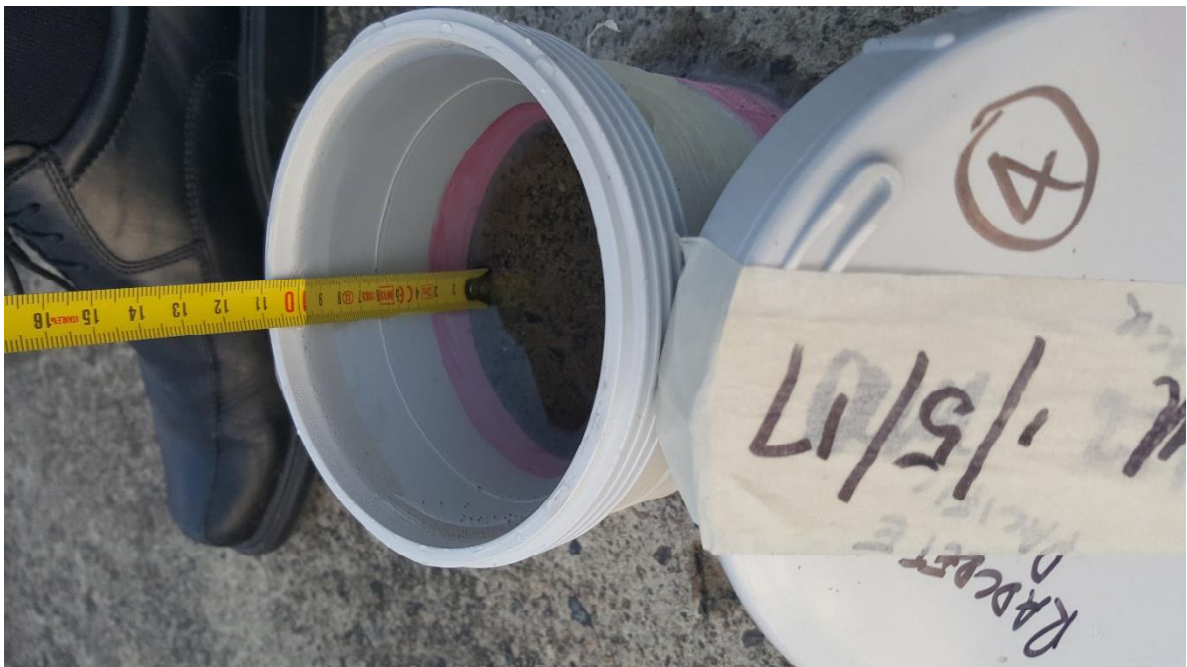
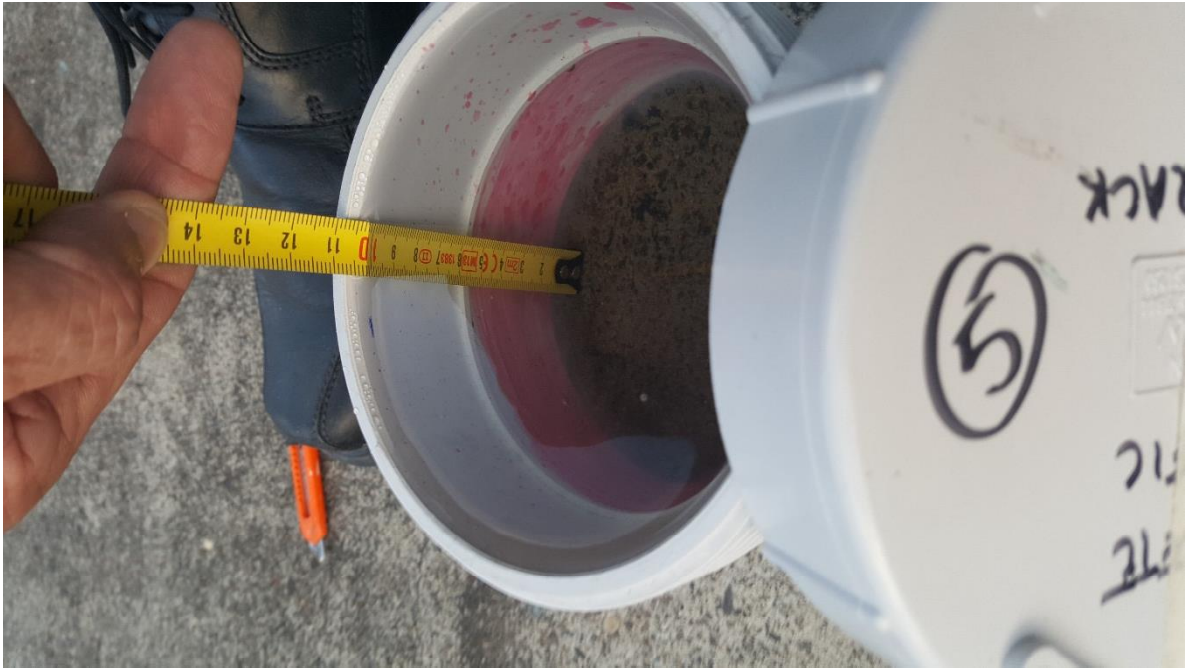
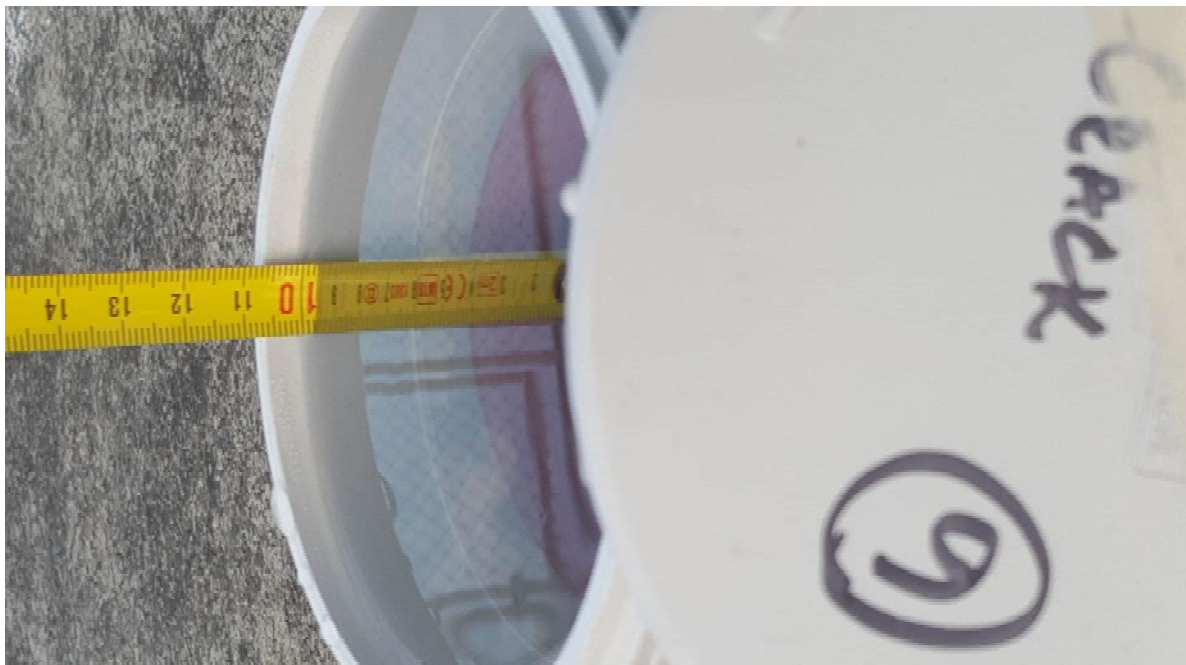
- Location 1 (Uncracked) – 5mm
- Location 2 (Uncracked) – 9mm
- Location 3 (Cracked) – 11mm
- Location 4 (Cracked) – 7mm
- Location 5 (Uncracked) – 5mm
- Location 6 (Cracked) - 6mm

The water level in each reservoir at the time of measurement can be seen in Photographs C1 to C6 in Appendix C.

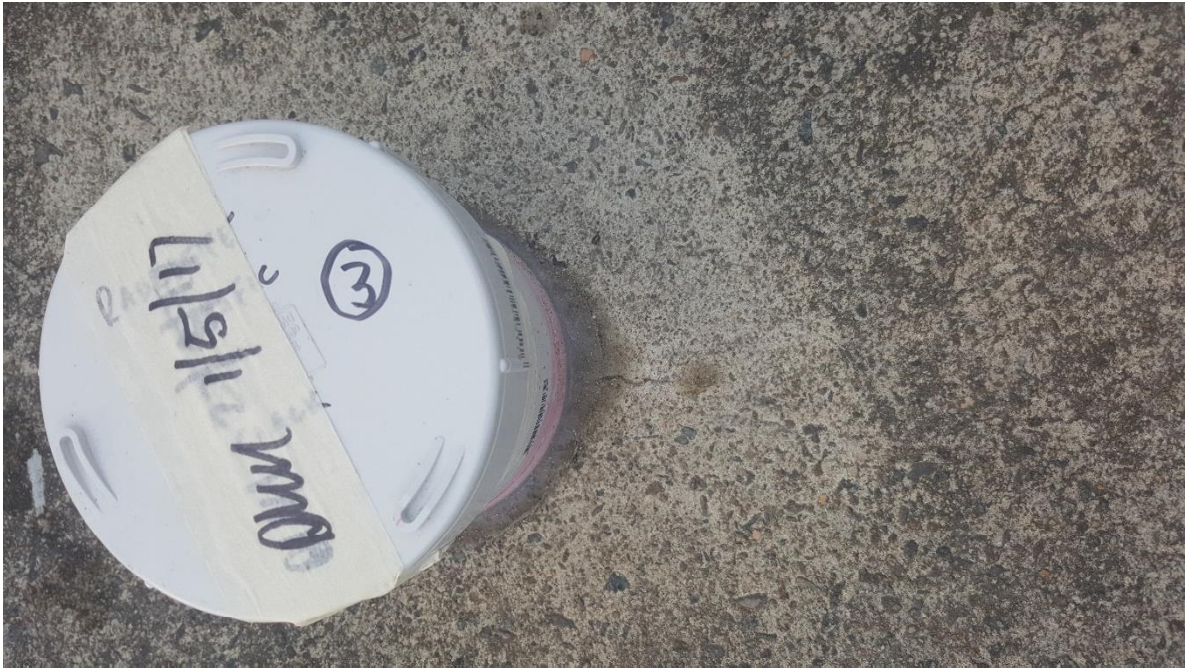
C7

The damp patch along the crack at location 3 had reduced significantly in size between visits 2 and 3 (see Photograph C7). The dampness along the crack at location 2 had disappeared completely. The dampness along the crack at location 6 remained constant between visits (Photograph C8).
